**Flood Control Project Maintenance
Levee Inspections**

Fall 2018 Levee Maintenance Deficiency Summary Report

Reclamation District No. 0785 Driver

Levee Inspection Report By Mile - Fall 2018

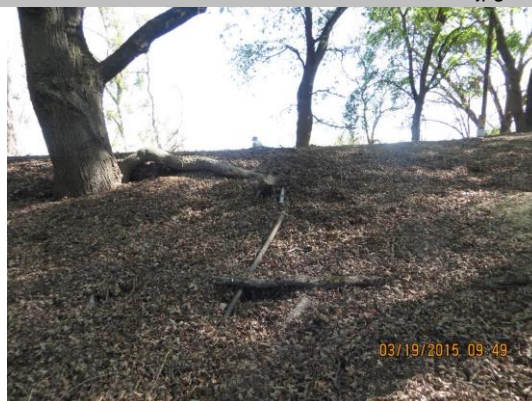
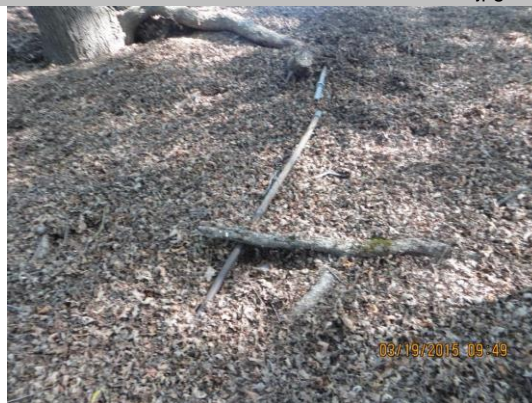
FS_ID:43965
DS_ID:22976
EP_NO: N/A
Repair Type: Non-Urgent
Crossing Status: Found
UCIP Comments: Pipe appears abandoned and should be done so properly.
FIELD_STRUCT_DESC: 1 of 2: 12-inch steel irrigation discharge pipe through the levee, 11 feet below the crown. Slant pump on the waterside (WS) slope. Pipe crosses under highway fill and discharges into an irrigation ditch. [Additional Reference(s): DWR Levee Log, 1988].
FS Date: 3/19/2015

Pipe visible on LS slope.

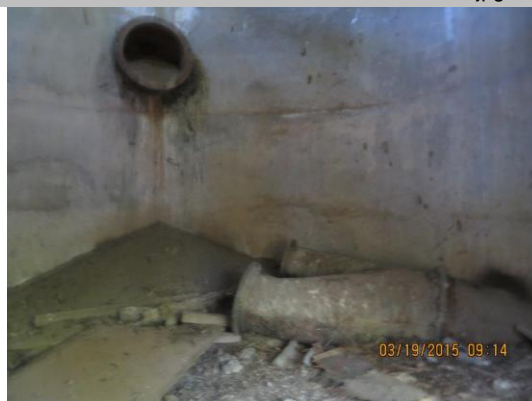
Comment Code						
Inspector Comment						
FS_ID:53407 DS_ID:22974 EP_NO: N/A Repair Type: Non-Urgent Crossing Status: Found UCIP Comments: 07/17/2018 Unable to acces pumphouse due to heavy vegetation. No integrity issue observed, therefore crossing downgraded to "Non-Urgent". Crossing is a part of DWR DMP Phase1 for internal video inspection. (O.Yakimov-DWR UCIP)07/18/2016 Same as last inspection. Pipe is silted in as visible through the LS pumphouse. (K. Fazel - UCIP)03/19/2015 Pipe appears to be abandoned and should be done so properly as it is open on the LS inside the pumphouse. Dense vegetation on both sides of the levee. (G. Wylie - FPIIB) FIELD_STRUCT_DESC: *ABANDONED* 30-inch steel pipe of an unknown purpose through the levee, 10 feet below the crown. Landside (LS) end open inside a concrete pump house on the LS shoulder. Unable to find the pipe on the waterside (WS). [Additional Reference(s): DWR Levee Log, 1988. USACE Sacramento O&M Manual 122.1, August 1955, (RM 70.05), 18-inch pipe referenced, invert elevation 33.4 feet]. FS Date: 7/17/2018 7:50:37 AM

Pipe open at base of concrete building on LS shoulder. No pump found.

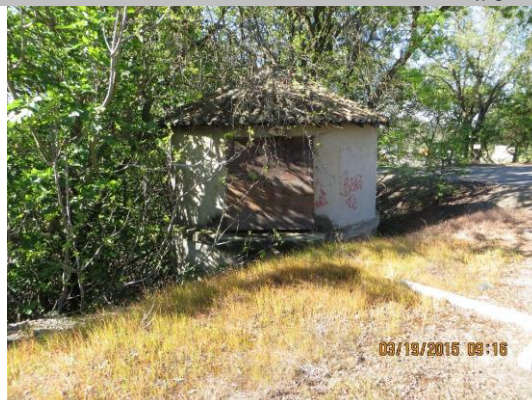
Pumphouse on LS shoulder.

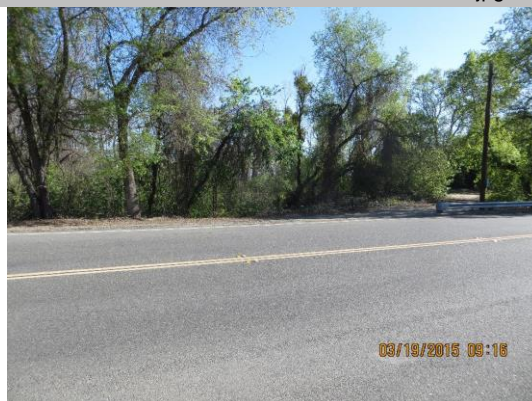
Comment Code						
Inspector Comment						
FS_ID:53407 DS_ID:22974 EP_NO: N/A Repair Type: Non-Urgent Crossing Status: Found UCIP Comments: 07/17/2018 Unable to acces pumphouse due to heavy vegetation. No integrity issue observed, therefore crossing downgraded to "Non-Urgent". Crossing is a part of DWR DMP Phase1 for internal video inspection. (O.Yakimov-DWR UCIP)07/18/2016 Same as last inspection. Pipe is silted in as visible through the LS pumphouse. (K. Fazel - UCIP)03/19/2015 Pipe appears to be abandoned and should be done so properly as it is open on the LS inside the pumphouse. Dense vegetation on both sides of the levee. (G. Wylie - FPIIB) FIELD_STRUCT_DESC: *ABANDONED* 30-inch steel pipe of an unknown purpose through the levee, 10 feet below the crown. Landside (LS) end open inside a concrete pump house on the LS shoulder. Unable to find the pipe on the waterside (WS). [Additional Reference(s): DWR Levee Log, 1988. USACE Sacramento O&M Manual 122.1, August 1955, (RM 70.05), 18-inch pipe referenced, invert elevation 33.4 feet]. FS Date: 7/17/2018 7:50:37 AM

WS shoulder heavily vegetated. unable to search for pipe.

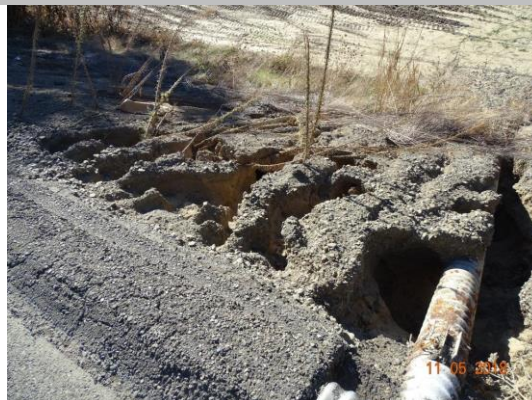
LM Start	0.11	Rating **	U	Issue No.	9
LM End	0.11	Issue Type +	Ma	Location *	LS
Category	Earthen Levee			GPS Latitude/Longitude	
				Start	End
Item	Erosion / Bank Caving			38.660211 °	38.660211 °
				-121.611748 °	-121.611748 °
DWR ID	DWR_RD0785_01_f_2017_9				
Comment Code					
E2 : Schedule repair of erosion site prior to the next inspection.					
Inspector Comment					
Runoff erosion on landside slope that has gotten worse.

Updated view of erosion on the landside slope. Fall 2018.

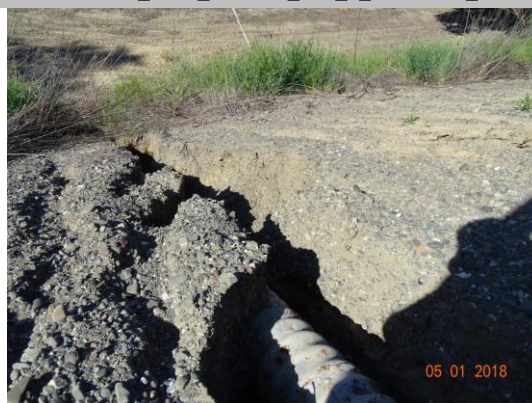
View of runoff on the landside slope. Spring 2018.

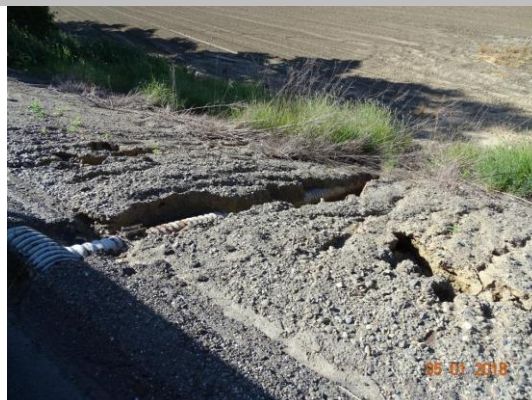
Additional view of runoff on the landside slope. Spring 2018.

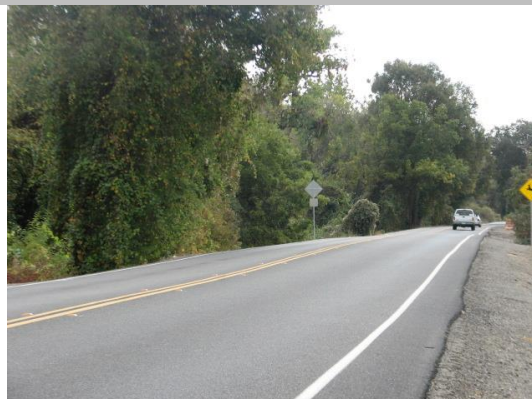
LM Start	0.21	Rating **	M	Issue No.	16
LM End	1.35	Issue Type +	Ma	Location *	WS
Category	Earthen Levee			GPS Latitude/Longitude	
				Start	End
Item	Vegetation			38.659340 °	38.646093 °
				-121.610405 °	-121.598518 °
DWR ID	DWR_RD0785_01_f_2013_16				
Comment Code					
V2 : Remove the wild growth other than native grasses from the levee slopes.					
Inspector Comment

Brush and other vegetation partially blocks visibility or access to the levee slope. Fall 2013

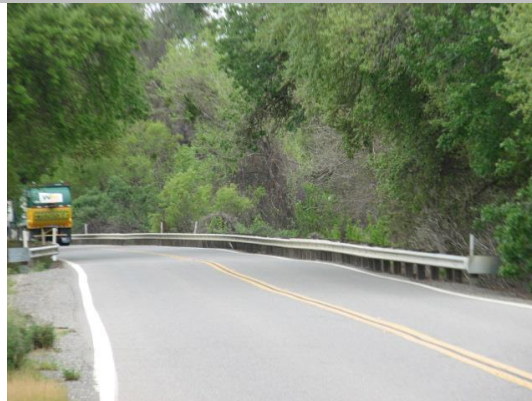
Brush and other vegetation partially blocks visibility. Spring 2014

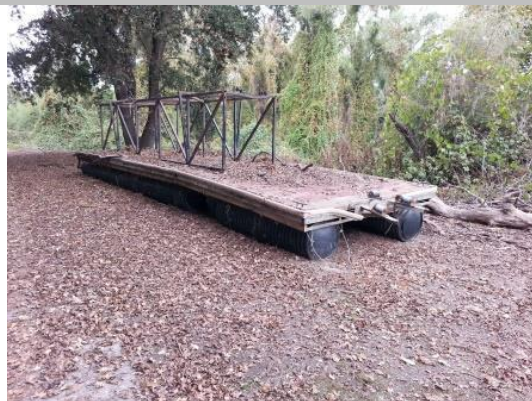
Updated view of old dock on crown/waterward side. Fall 2016.

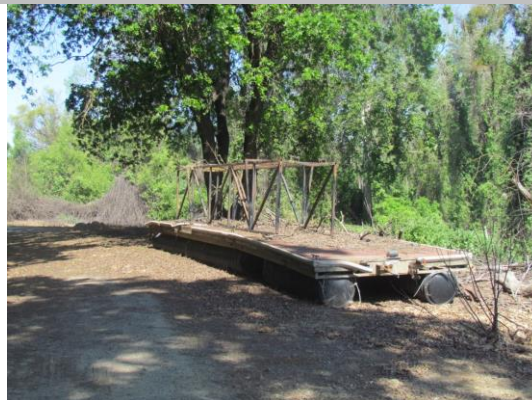
View of a old dock on the waterward side of the levee looking upstream.
Spring 2015.

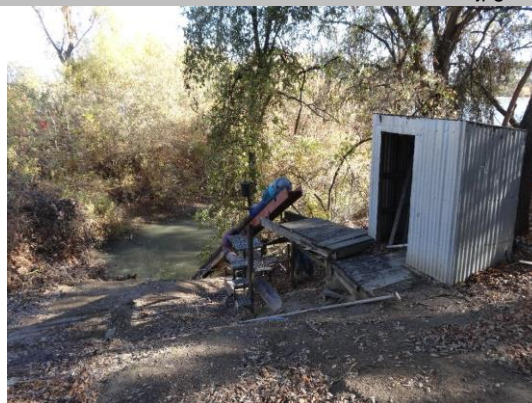
LM Start	0.63	Rating **	M	Issue No.	359
LM End	0.63	Issue Type +	En	Location *	
Category	Supplemental			GPS Latitude/Longitude	
				Start	End
Item	DWR UCIP Field Study			38.654641 °	38.654641 °
				-121.605538 °	-121.605538 °
DWR ID	22982				
Comment Code					
Inspector Comment					
FS_ID:43963 DS_ID:22982 EP_NO: N/A Repair Type: Non-Urgent Crossing Status: Found UCIP Comments: Part of abandoned pipe also found on waterside that should be removed.No access to landside across the highway. FIELD_STRUCT_DESC: 2 of 2: 0.75-inch steel electrical conduit through the levee, 1 foot below the crown. [Additional Reference(s): DWR Levee Log, 1988]. FS Date: 11/21/2013

WS view: slant pump, walkway, and electric control box in shed on levee slope.

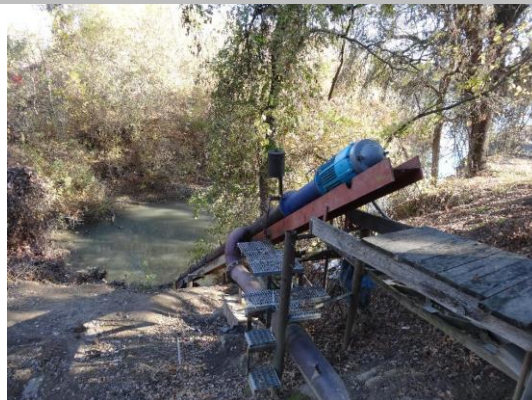
WS view: slant pump and walkway on levee slope.

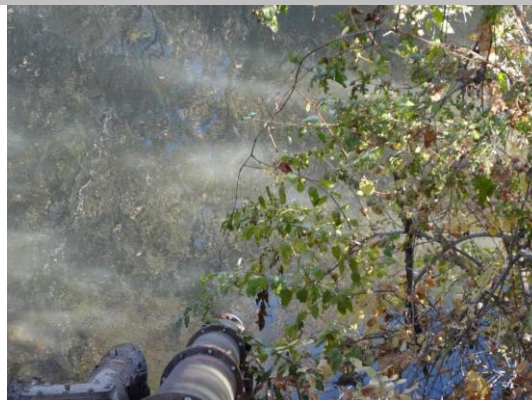
WS view: two steel pipes on levee slope. Abandoned pipe on left.

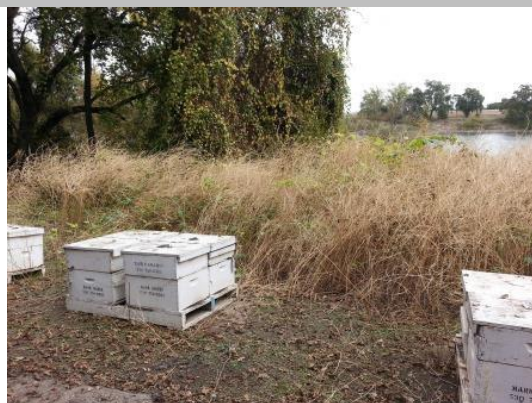
View of vegetation site on WS slope. Fall 2016.

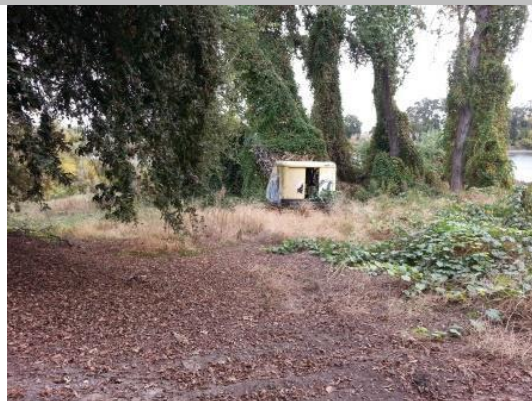
View of an abandoned crane on waterward side of the levee. Fall 2016.

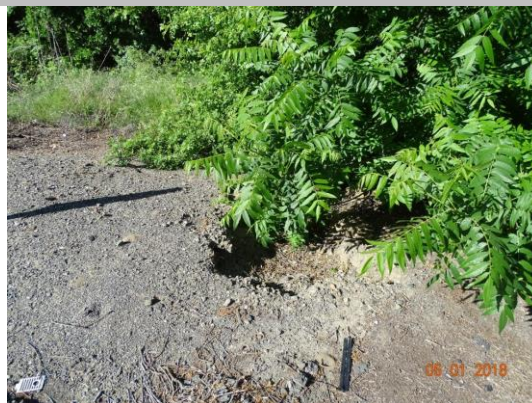
LM Start	0.77	Rating **	M	Issue No.	4
LM End	0.77	Issue Type +	Ma	Location *	LS
Category	Earthen Levee			GPS Latitude/Longitude	
				Start	End
Item	Erosion / Bank Caving			38.652825 °	38.652825 °
				-121.604920 °	-121.604920 °
DWR ID	DWR_RD0785_01_s_2018_4				
Comment Code					
E1 : Note and monitor erosion site.					
Inspector Comment					
Runoff on landside slope.

View of runoff erosion on the landside slope. Spring 2018.

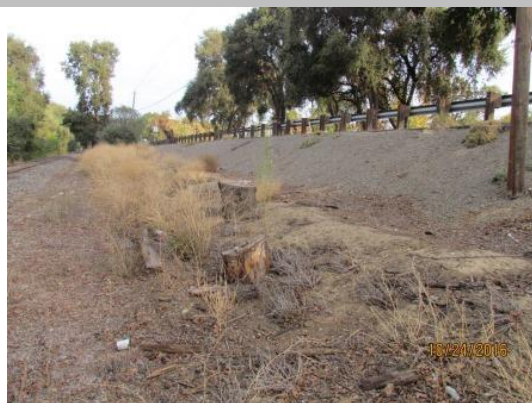
Two tree stumps near levee toe on landside. Fall 2016.

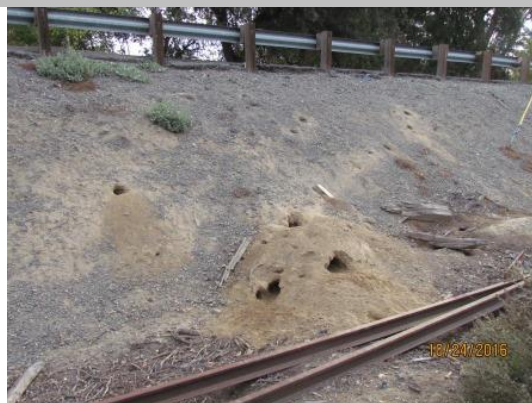
LM Start	1.02	Rating **	M	Issue No.	29
LM End	1.02	Issue Type +	Ma	Location *	LS
Category	Earthen Levee			GPS Latitude/Longitude	
				Start	End
Item	Animal Control			38.649798 °	38.649798 °
				-121.602373 °	-121.602373 °
DWR ID	DWR_RD0785_01_f_2016_29				
Comment Code					
A3 : No rodents visible, but rodent burrows visible; need to backfill and compact or grout burrows.					
Inspector Comment					
Rodent holes on the landside slope.

View of rodent holes on LS slope. Fall 2016.

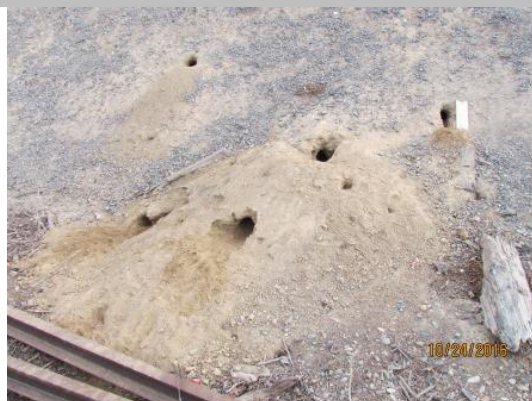
Another view of rodent holes. Fall 2016.

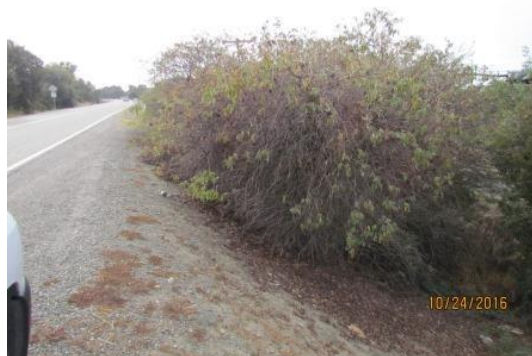
View of elderberry trees on LS slope. Fall 2016.

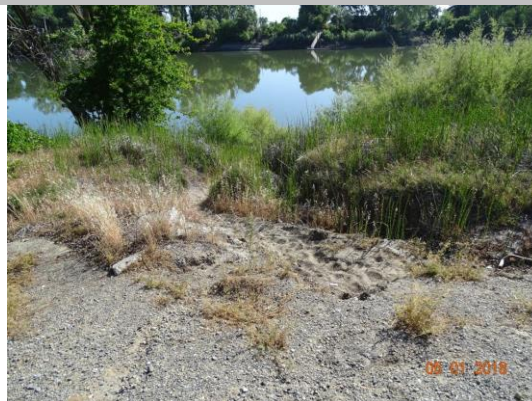
Updated view of slope stability on the waterside slope. Spring 2018.

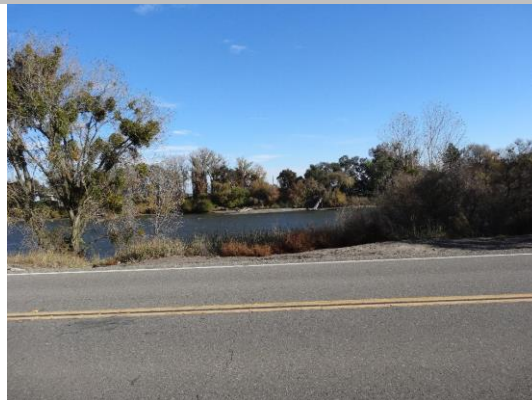
LM Start	1.31	Rating **	M	Issue No.	360	
LM End	1.31	Issue Type +	En	Location *		
Category	Supplemental			GPS Latitude/Longitude		
				Start	End	
Item	DWR UCIP Field Study			38.646547°	38.646547°	
				-121.598924°	-121.598924°	
DWR ID	22978					
Comment Code						
Inspector Comment						
FS_ID:41984 DS_ID:22978 EP_NO: N/A Repair Type: Non-Urgent Crossing Status: Found UCIP Comments: Dense vegetation on waterside. No pipe found/visible on waterside. FIELD_STRUCT_DESC: 12-inch steel pipe of an unknown purpose through the levee, 6 feet below the crown. Steel plate bolted to each end. [Additional Reference(s): DWR Levee Log, 1988]. FS Date: 11/21/2013

WS view: crown and waterside. No pipe found due to dense vegetation.

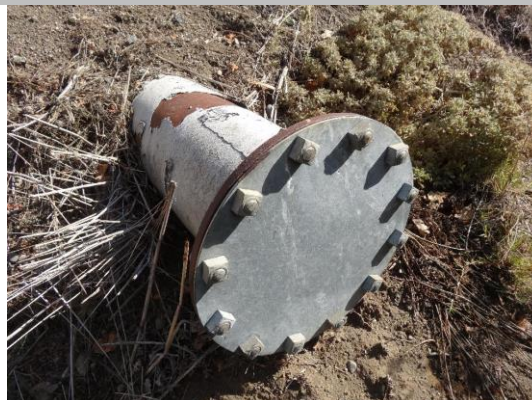
LS view: plate bolted pipe on levee slope.

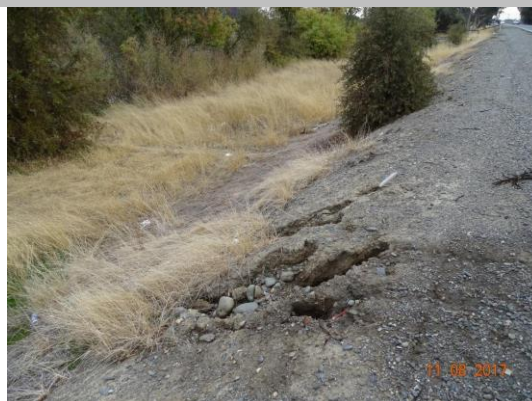
LM Start	1.51	Rating **	M	Issue No.	55
LM End	1.51	Issue Type +	Ma	Location *	WS
Category	Earthen Levee			GPS Latitude/Longitude	
				Start	End
Item	Erosion / Bank Caving			38.644349 °	38.644349 °
				-121.596506 °	-121.596506 °
DWR ID	DWR_RD0785_01_f_2017_55				
Comment Code					
E2 : Schedule repair of erosion site prior to the next inspection.					
Inspector Comment					
Runoff on waterside slope.

View of the runoff erosion on the waterside slope. Fall 2017.

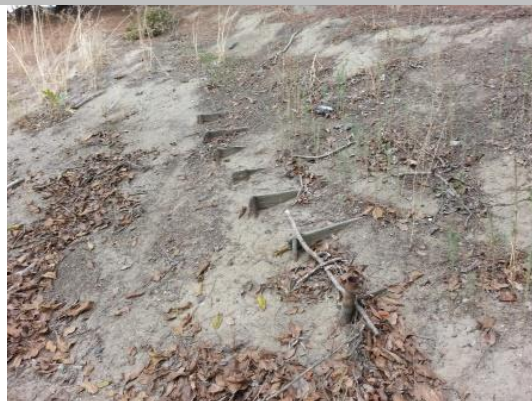
View of old abandoned stairway on LS slope. Fall 2016.

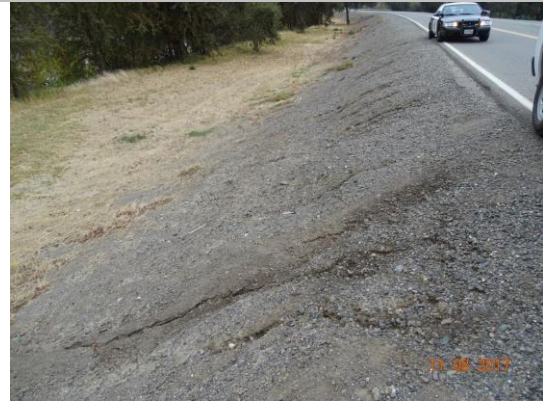
LM Start	2.23	Rating **	A/W	Issue No.	19
LM End	2.23	Issue Type +	Ma	Location *	WS
Category	Earthen Levee			GPS Latitude/Longitude	
				Start	End
Item	Erosion / Bank Caving			38.642908 °	38.642908 °
				-121.584647 °	-121.584647 °
DWR ID	DWR_RD0785_01_s_2018_19				
Comment Code					
E1 : Note and monitor erosion site.					
Inspector Comment					
Runoff erosion on waterside slope. Recommend monitoring.

View of runoff erosion on the waterside slope. Fall 2017.

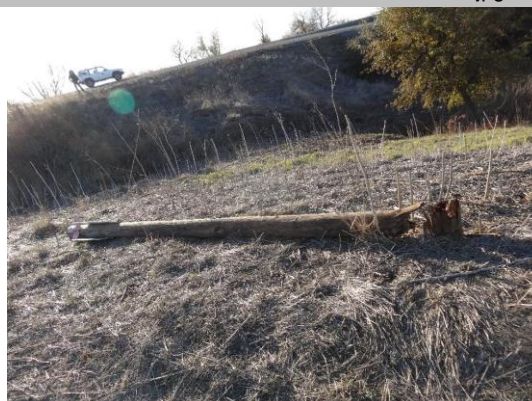
LM Start	0.01	Rating **	M	Issue No.	281
LM End	0.01	Issue Type +	En	Location *	
Category	Supplemental			GPS Latitude/Longitude	
				Start	End
Item	DWR UCIP Field Study			38.641086 °	38.641086 °
				-121.620350 °	-121.620350 °
DWR ID	22985				
Comment Code					
Inspector Comment					
FS_ID:24750 DS_ID:22985 EP_NO: 16982 Repair Type: Non-Urgent Crossing Status: Indicator Found UCIP Comments: Only a damaged indicator post found on landside across the road.Damaged indicator needs to be fixed. FIELD_STRUCT_DESC: Three 2-inch-diameter and three 1.5-inch diameter HDPE conduits containing fiber optic cables across and under the east levee (County Road 124), 67 feet below the crown. HDPE pipes were pulled through an 8-inch bore hole and backfilled with bentonite. (App. No. 16982 - Pacific Fiber Link) FS Date: 12/2/2013

LS view: damaged indicator post across the levee road.

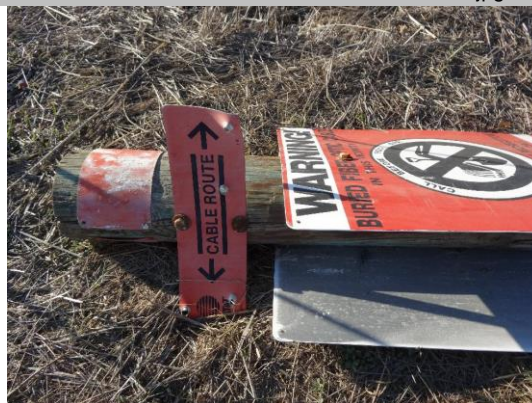
LS view: closer view of damaged indicator post.

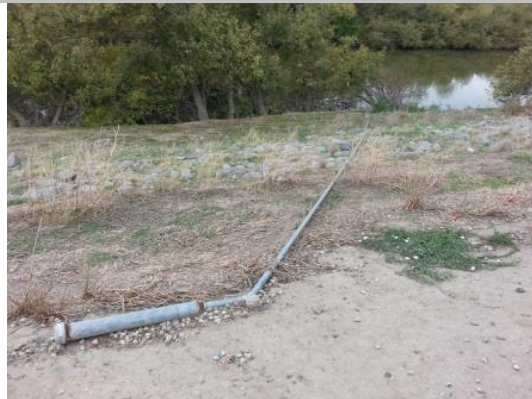
View of a capped galvanized pipe on WS slope. Fall 2016.

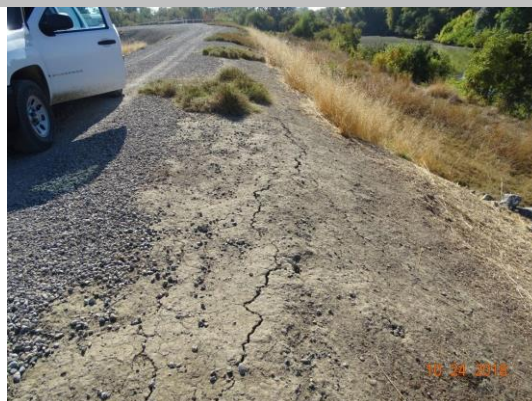
LM Start	3.26	Rating **	A/W	Issue No.	5
LM End	3.26	Issue Type +	Ma	Location *	WS
Category	Earthen Levee			GPS Latitude/Longitude	
				Start	End
Item	Cracking			38.600148°	38.600148°
				-121.590880°	-121.590880°
DWR ID	DWR_RD0785_02_f_2018_5				
Comment Code					
CR1 : Monitor and have inspected by geotechnical engineer.					
Inspector Comment					
Cracking on the waterside shoulder. Approximately 50' long. Recommend monitoring.

View of cracks on the waterside shoulder. Fall 2018.
